INSTALLATION SHEET

4 - FOLD

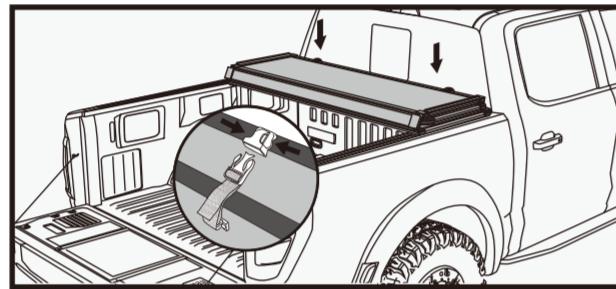
Step 2:

1. Place cover assembly on both side of front truck bed rail against the cab.
2. Release safety buckles.

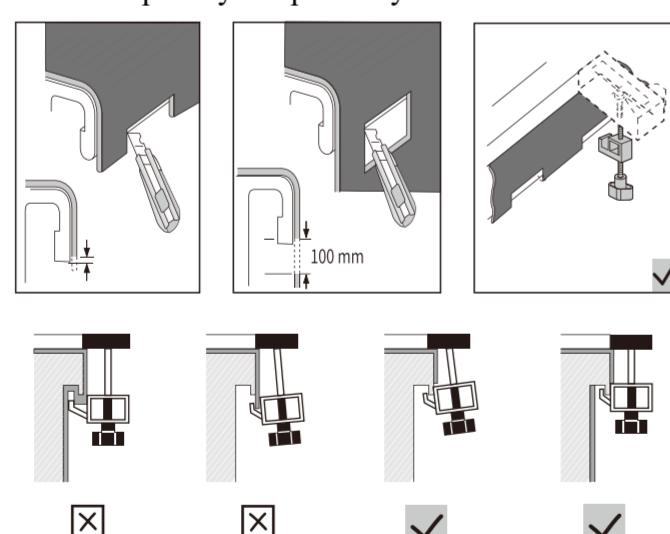
Step 4:

1. Pull down the front clamp to vertical position.
2. Loosen the knob and slide front clamp to bed rail.
3. Stick the clamp pad to mounting position on bed rail.
4. Hook the J-shaped clamp under the metal bed rail and tighten the knob.

Hand tighten only, do not over tighten.

Cutting the bedliner is necessary.
The clamps may not precisely vertical.

The clamps may not precisely vertical

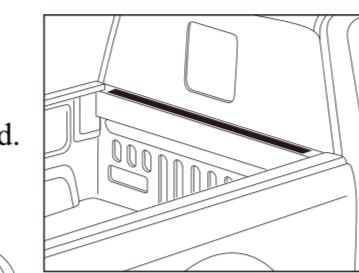
Step 1:

1. Clean the bulkhead and bed rail before installation
2. Some truck's front bed railings are lowered. You need to stick sealing strips on the bed railings before installing the cover.

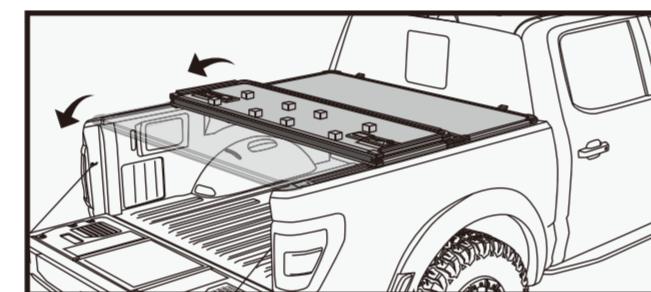
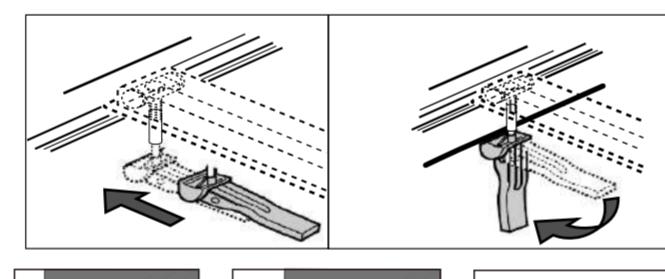
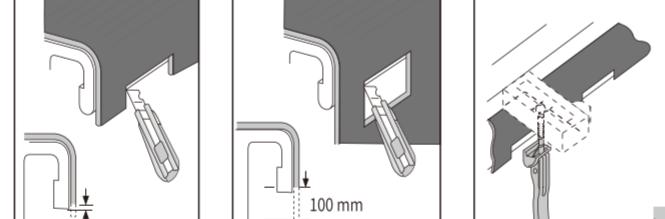
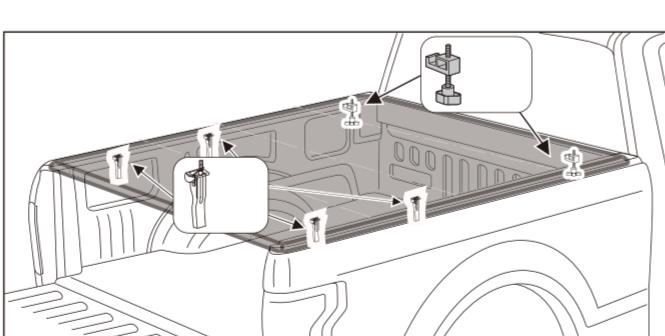
Step 3:

Fully unfold the cover and secure the rear clamp.

1. Pull down the rear clamp to vertical position.
2. Slide rear clamp to bed rail.
3. Stick the clamp pad to mounting position on bed rail.
4. Turn the clamp handle to adjust rear clamp to proper length.
5. Hook the J-shaped clamp under the metal bed rail and push the clamp handle to vertical position.

The clamps may not be precisely vertical.

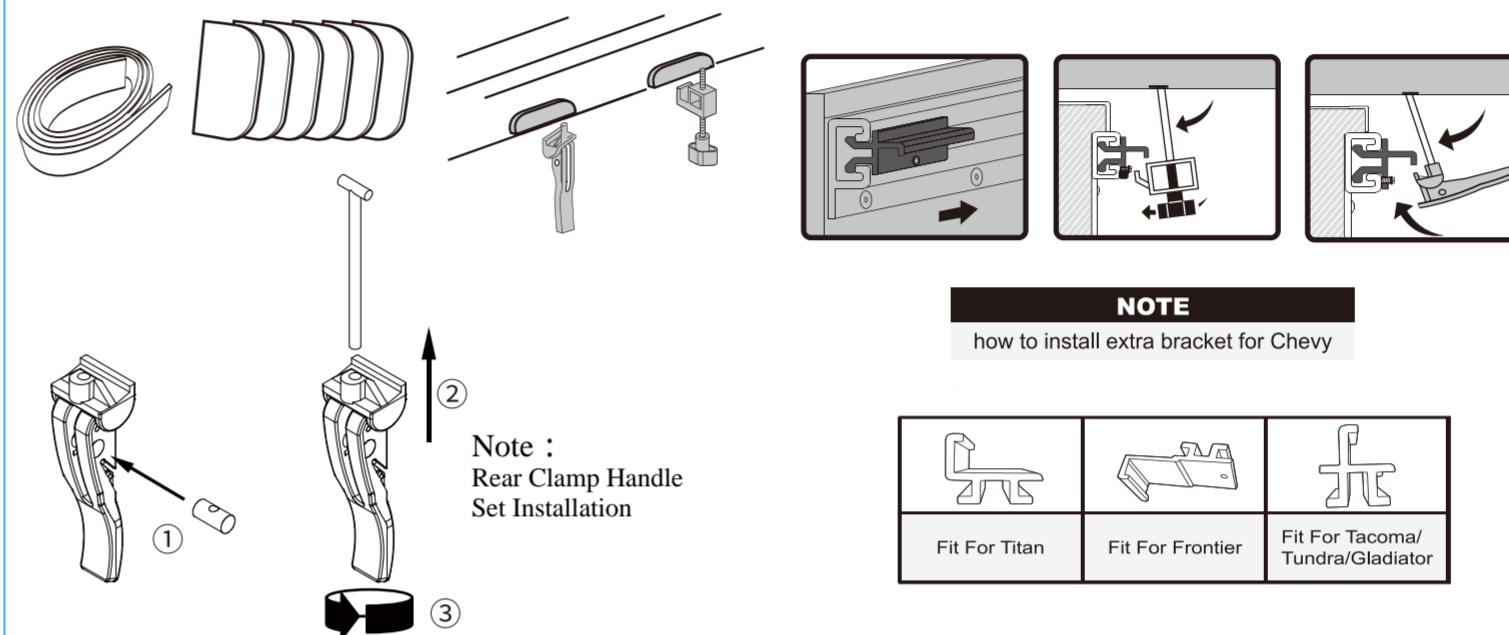
Step 5:

1. Seal the tailgate with seal foam strip
2. Stick the front seal strip on the front of bed rail.

NOTE
how to install extra bracket for Chevy

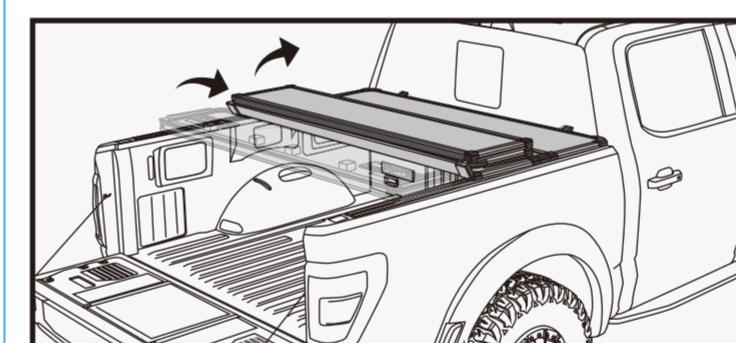
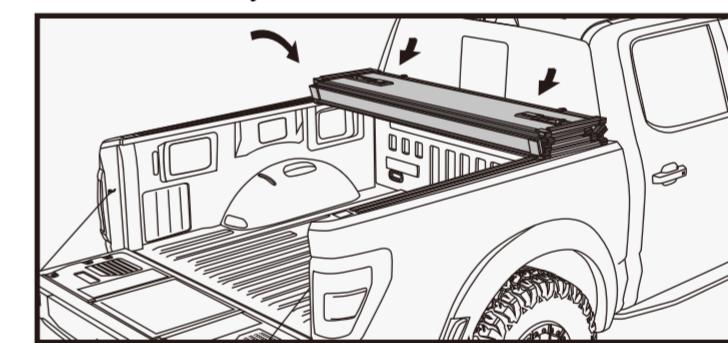
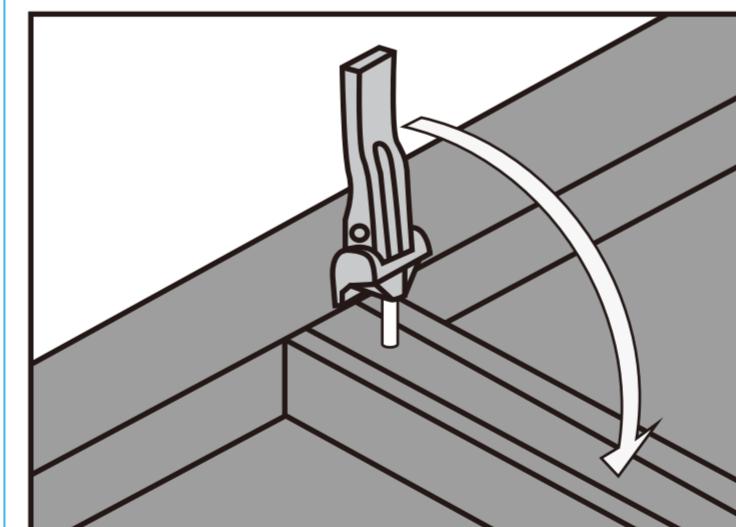
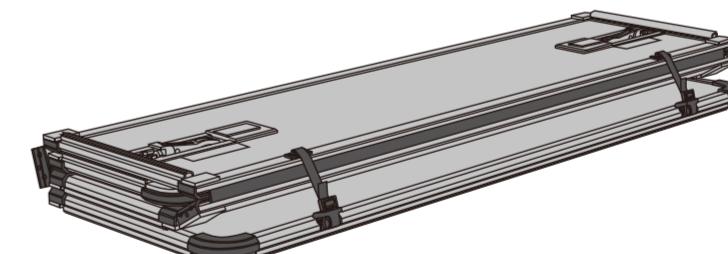
Step 6:

Fold up the cover

1. Open the tailgate and release the rear clamps.
2. Fold up the first panel.
3. Fold and secure the rear clamps back to original position.

Please check clamps and secure straps are tight.
